Removing the RF(capacitor) modification

From Mid 2018 to Mid 2019 a small capacitor was added to MS2000, RM2000 controllers to reduce RF emissions. When this capacitor fails it grounds the oscillator preventing the microcontroller from running. When this happens controller doesn't respond to serial/usb input, joystick, knob and the LCD is blank or full of bars.

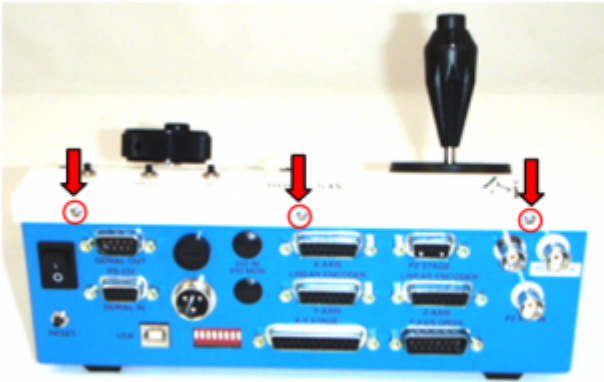
Second, using the Phillips screwdriver, remove the three upper screws that attach the top of the lid, see picture. Then turn the controller over on a small box or a piece of foam to protect the joystick and remove the three lower screws, see picture. Save the screws for reassembly.

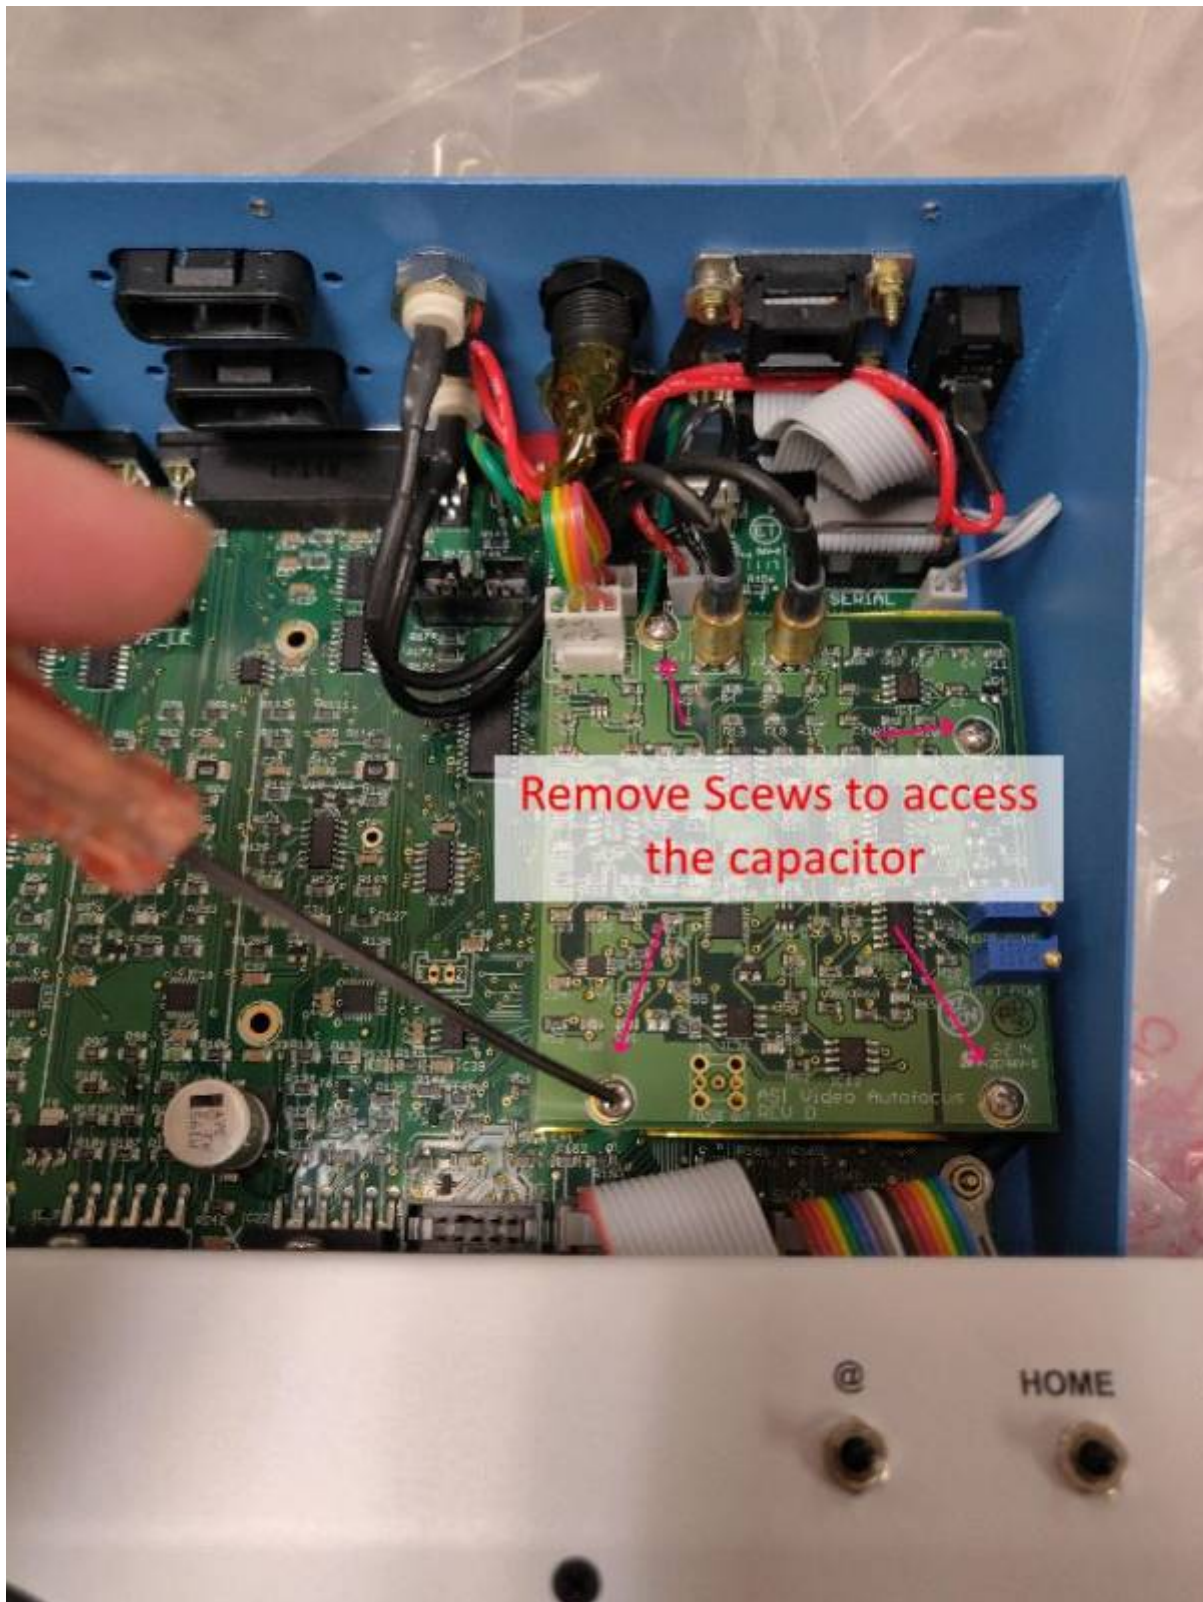
Some controllers might have an add-on card like the autofocus or crisp system blocking access to the capacitor. Unmount it by unscrewing the four screws holding it in place.

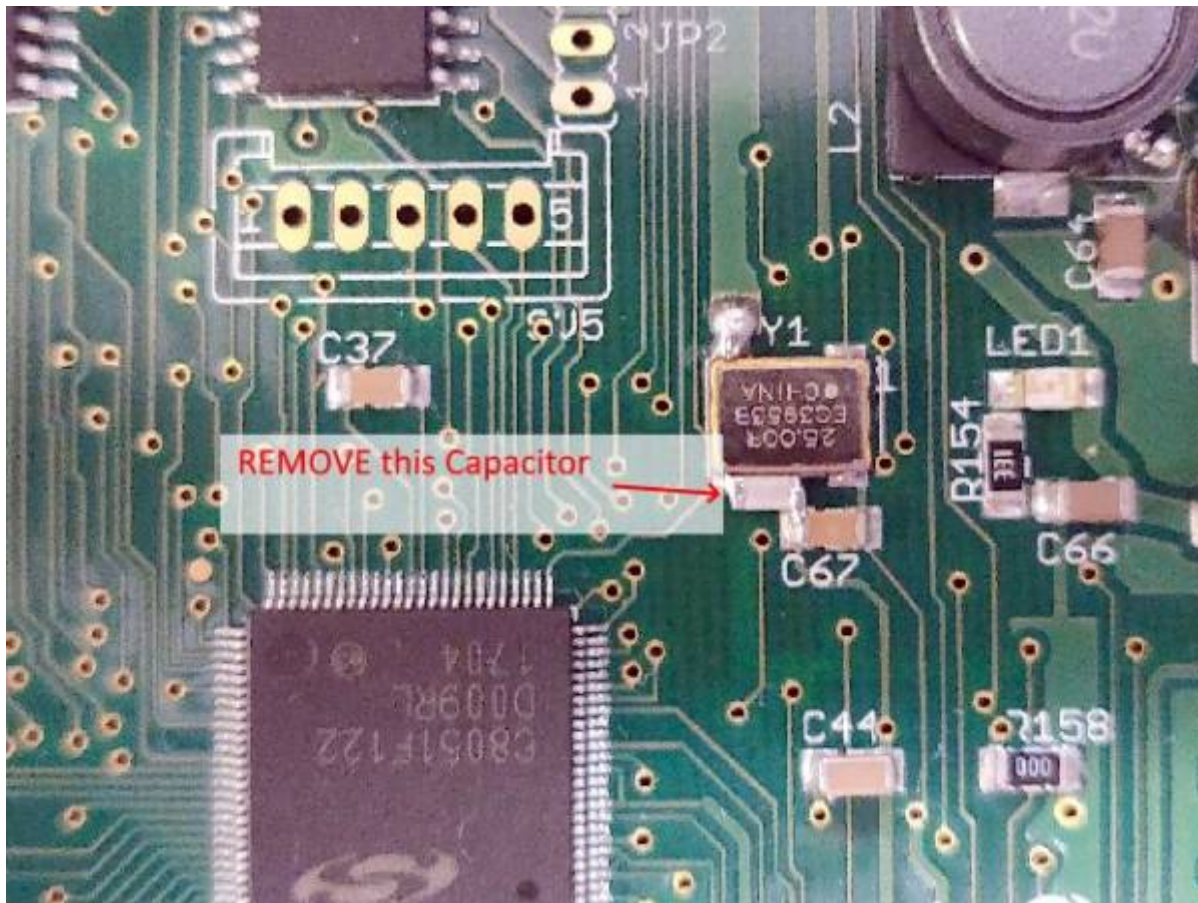
Then look for the oscillator Y1, next to it are two capacitors, one white and another mustard color. Remove the white capacitor (refer to the attached picture), you may have to remove the mustard one as well.

They are bypass caps, the system can work without them. But if they are broken, they short the voltage rails and prevent the system from booting. Hopefully, the power regulators onboard haven't failed.

Then power the controller and test it, if it doesn't work, put the mustard one back in and test it again.
