Synchronous Encoder Reporting

TTL Report Module

This section of the manual applies to the `TTL_REPORT_INT` firmware module. Including this module in the firmware allows for precisely synchronized encoder position reporting. The user's hardware supplies a TTL trigger to the MS-2000 that causes a processor interrupt which performs an encoder-read operation on all of the controller's motorized axes. Any firmware build that includes this module is not capable of any other TTL input modes and will only perform the functionality of the `TTL_REPORT_INT` module.

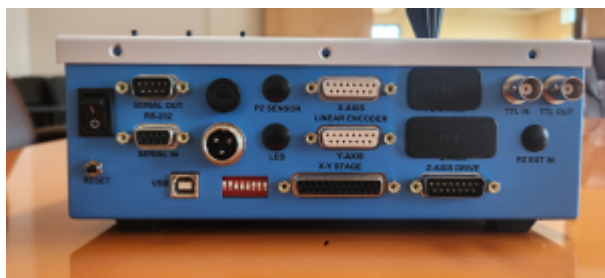
A standard MS-2000 with RS-232 **SERIAL OUT**

As you can see in the image, this MS-2000 has the serial port connector. You may have a controller configured for CRISP that replaces this port with a male DB9 connector. In that case, you will need to

To use the optional `SERIAL_OUT` module, the controller requires the RS-232 **SERIAL OUT** port on the back of the MS-2000, this feature uses the second serial port to output the report.

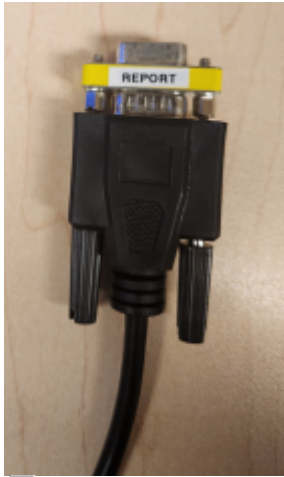
Straight through serial cable with gender changer

You will also need a straight through serial cable (not a null modem cable) with a gender changer to connect the **SERIAL OUT** to the input of the serial port on another computer.

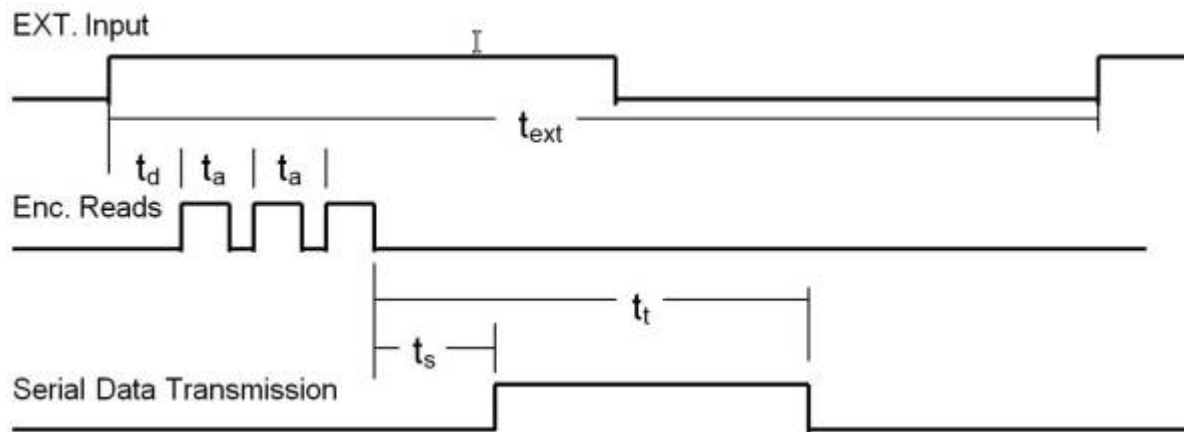
Timing Specifications

Item	Symbol	Spec. Values		Unit
		Min	Max	
Initial Read Delay	t_d	3.0	10.0	μ s
Successive Axis Read Delay	t_a	11	13	μ s
Serial Transmit Delay	t_s	110	500	μ s
Transmit Time†	t_t	1.2	1.75	ms
External re-trigger time†	t_{ext}	1.7		ms

(†) 115200 baud, three axes

The encoder read operations follows the external trigger input as indicated in the timing diagram. The largest jitter component comes from the delay in executing the interrupt service routine that performs the read operations. Most of the time the interrupt proceeds with the minimum delay time specified. Occasionally, the reads are delayed until current data bus operations complete.
